Tuesday, March 8, 2005

On Tuesday, we began the day by traveling to the FEDOPO clinic in Guaricano. When we arrived we were unsure of what we were going to do after the wealth of information we received on Monday. Luckily, a local resident named Rico gave us the idea of taking measurements of the cistern, which was still being called the well by some people. He showed us the mechanism by which the water was taken out of the well and into the jet pump that was attached to a pressure tank.

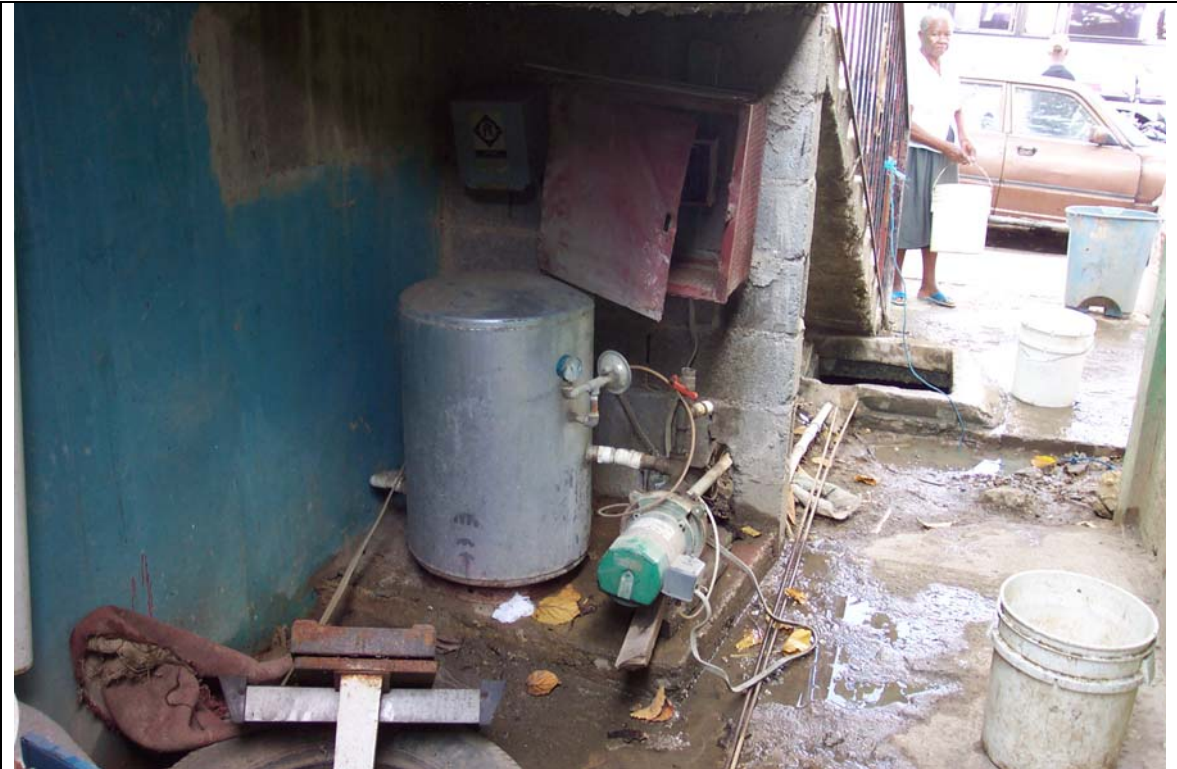
The Jet Pump and Pressure Tank in the Foreground, the Cistern in the Background

We also learned that the jet pump is currently broken, but still kind of works, it simply leaks a lot of water. When it is on, the pressure in the pressure tank is about 40 psi. Also, we noticed that the pipe connecting the cistern to the jet pump was leaking, and when we informed Juan Carlos, the electrician, he simply went over to it, yanked it out from the connector, put some glue on it, and put it back in. There were about 4 or 5 different pieces of pipe connected between the cistern and the jet pump, which was unnecessary because the pipe was straight.

There are three different controls above the jet pump in the picture above. In the red cage, the breakers to turn on the submersible pump are on the left, and the breakers to turn on the jet pump are on the right. To the left of the red cage is the submersible pump controller, which protects the pump from overheating, and has the starting circuitry for it. The schematic of the submersible pump controller is shown below:

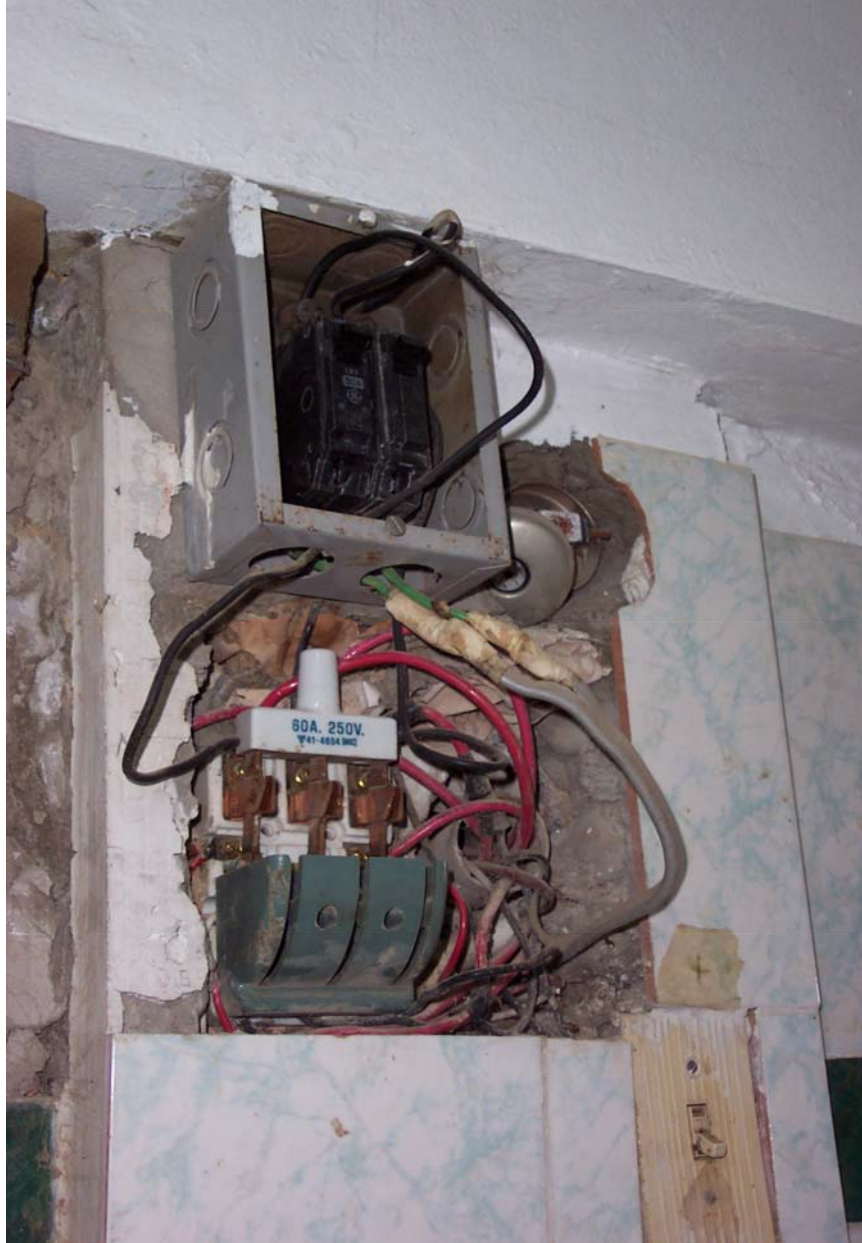
We then went inside the clinic with Juan Carlos the electrician we had met on Monday to find the electrical connections of the pumps to the transformer inside the building. The actual connection is inside the building on the left side of the emergency room on the first floor. It has two breakers one is 30 A, and the other is 20 A. There is also a large ceramic switch, we don't know what it is for, but it says 60 A, 250 V on it. This is also the place where the electricity comes into the building. It is then fed around the building to the other side, where the inverter, and batteries are located.

Breakers for Pumps and Where Power Enters Building

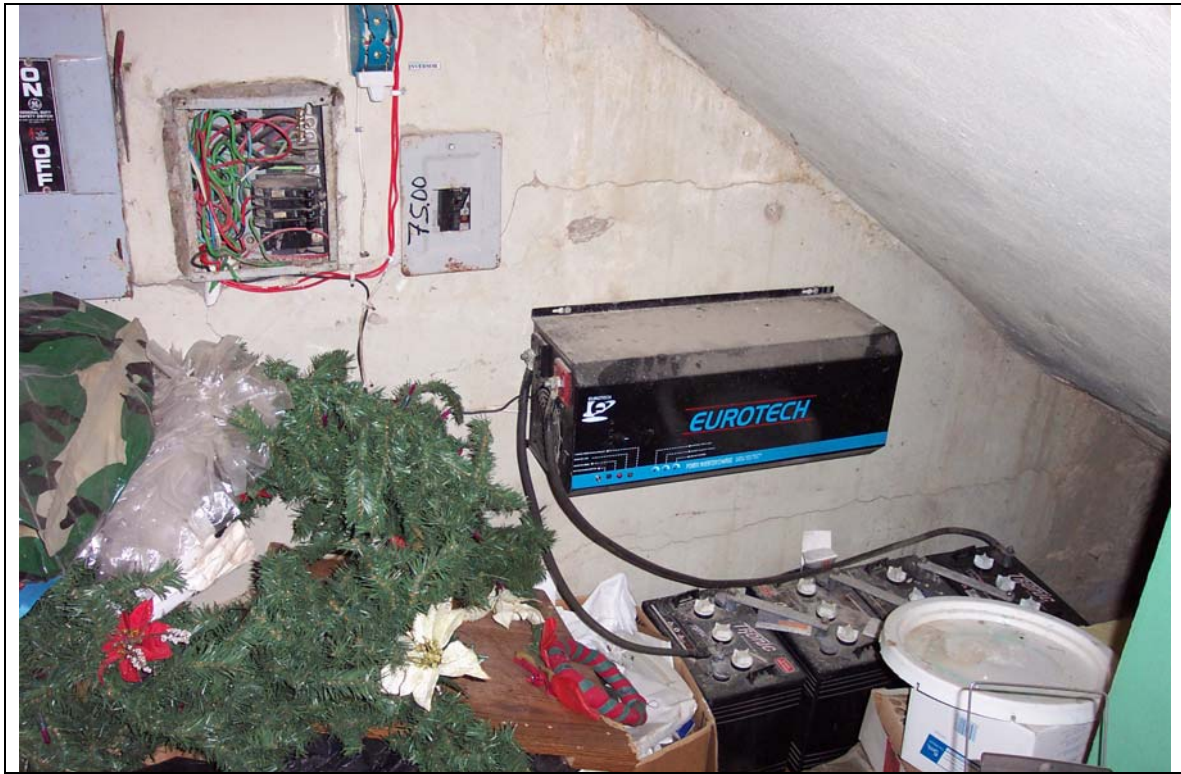
Inverter and Batteries

The batteries are all 6 V, 225 Amp-Hour batteries, which require maintenance. It seems that in the DR, you cannot purchase gel, sealed batteries for some reason. This may be because of the temperature or humidity, but we think it is simply because the country is not as technologically advanced as ours is. The inverter is a single-phase inverter and is plugged directly into the lines coming from the pump breakers on the other side of the building. The blue switch that is at the top of the picture is a manual switch between power from the grid and power from the batteries. The power from the grid is on between the hours of 8:30 am to 4:30 pm. After this the batteries must be used, along with the diesel generator, which is currently broken. Unfortunately, the clinic's power needs require the batteries to be discharged to 20% capacity, which makes the clinic have to replace the batteries every 6 months. Each battery costs approximately \$80 US, which means that they have an annual cost of \$640 or 17,920 pesos for the batteries, which is a lot of money to them. Simply replacing the batteries with sealed batteries, and a larger number of them would save them money. The box with all the wires in it contains the breakers for the first floor, and the breakers next to it are for the inverters.

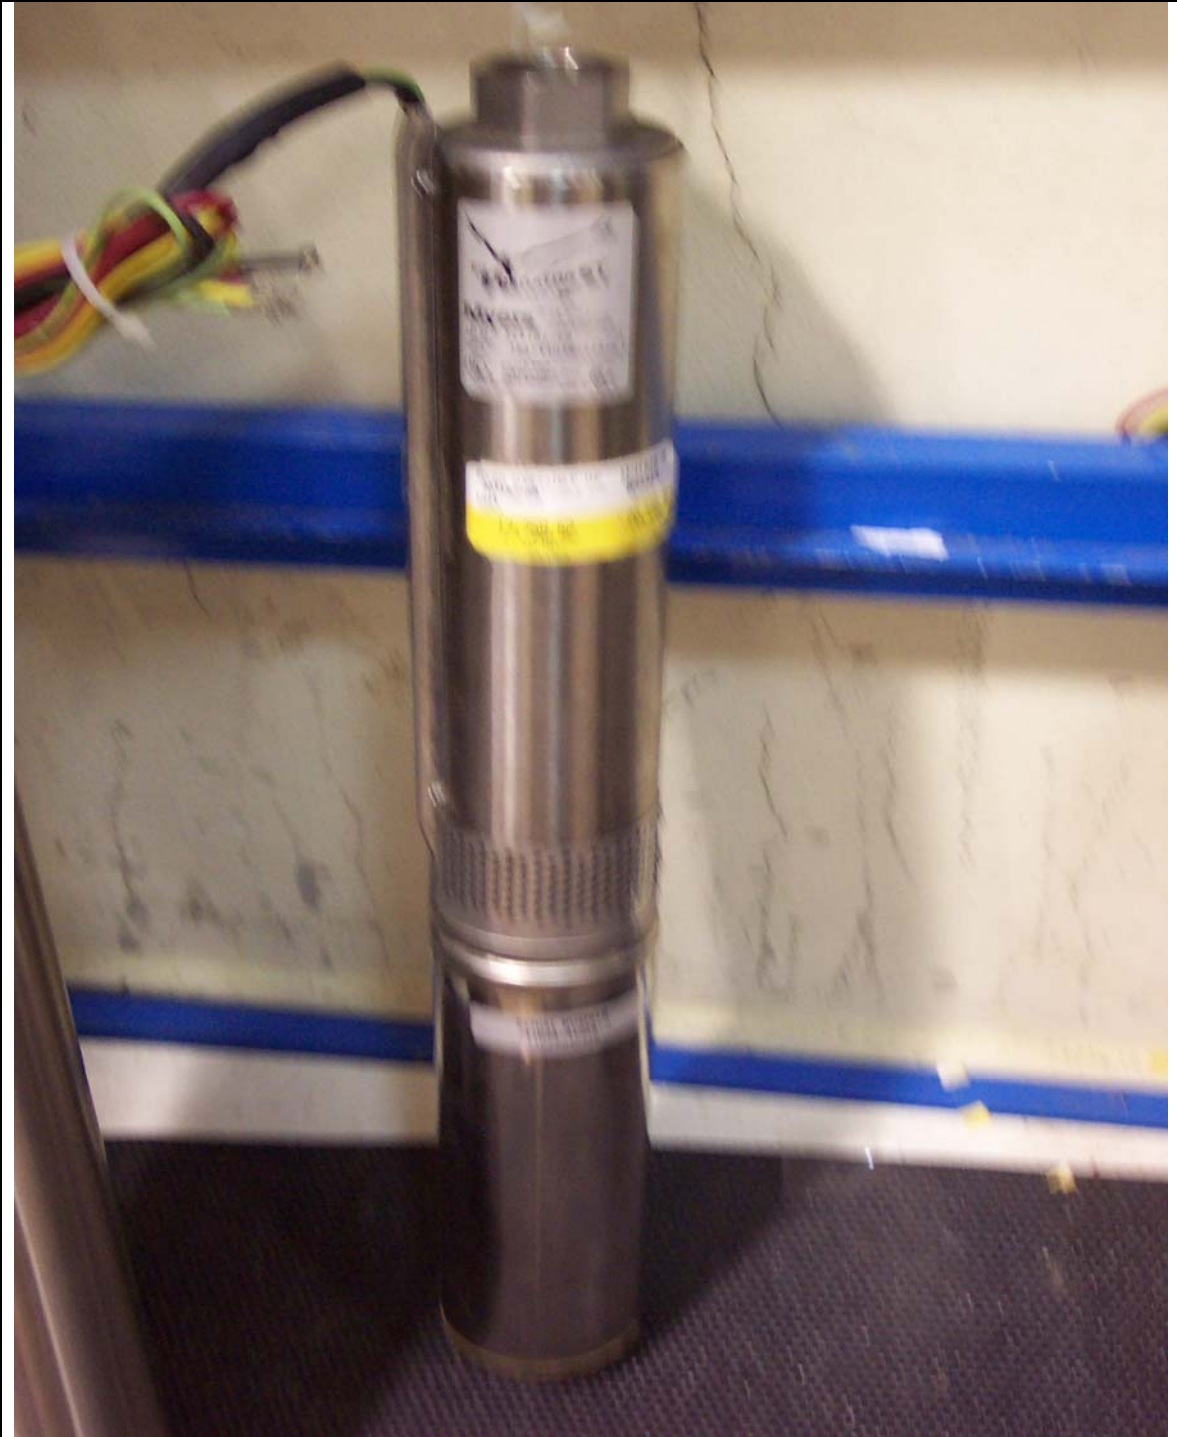
Unfortunately, this picture had to be taken secretly and is not very good. Basically the pump is made by Myers Pumps in Ashland, Ohio, and is a 1 HP single phase pump, called the Predator
